Manhole Inspection Summary

Manhole # S05AA2019MH

Location Address: **5930 SIMMONDS AVE**

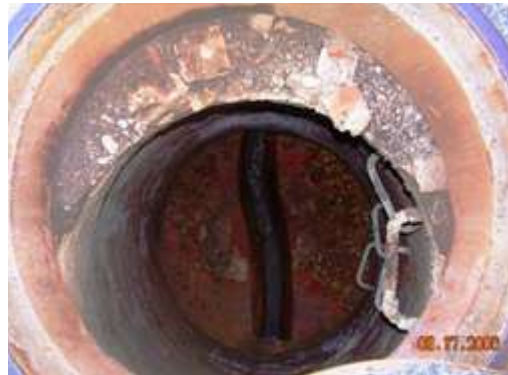
Top View

Count: **5** Missing: **0** ☒ **Corroded**

☒ **Evidence Of Surcharge** Depth: **1** (ft.) ☐ Active Surcharge Present

Corroded steps. Evidence of surcharge - Bench debris.

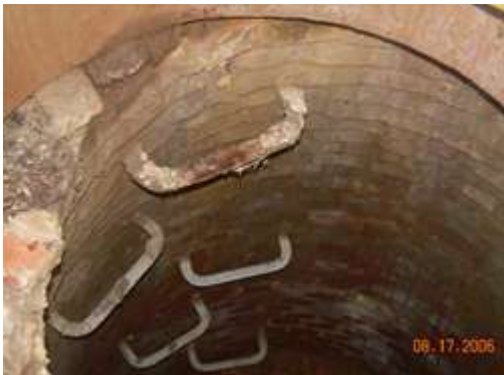
Defect

Condition: ☐ Sound ☐ Cracked ☒ **Leaks**

Condition: ☐ Sound ☐ Cracked ☐ Root Intrusion ☒ **Loose Brick** ☒ **Deteriorated**

Infiltration: ☐ None ☒ **Joint** ☐ Cracks ☒ **Mortar** ☐ Roots ☐ Wall

Frame leaks. Frame offset. Adjustment deterioration, loose brick and infiltration. Corbel and Barrel infiltration.

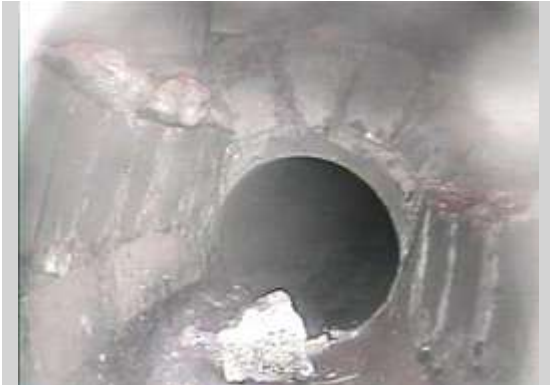
8 in. Circular Gravity Sewer Pipe Out @ 12 O'Clock

Barrel deterioration and infiltration.

Infiltration: **Evidence** Pipe Seal Cond: **Unknown**

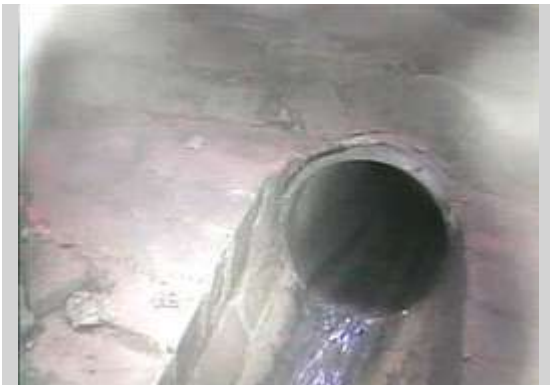
8 in. Circular Gravity Sewer Pipe In @ 6 O'Clock

Infiltration: **Evidence** Pipe Seal Cond: **Unknown**
